The effects of 2011 Ohio and Mississippi river valley flooding on Cairo, Illinois, area

Kenneth R. Olson and Lois Wright Morton

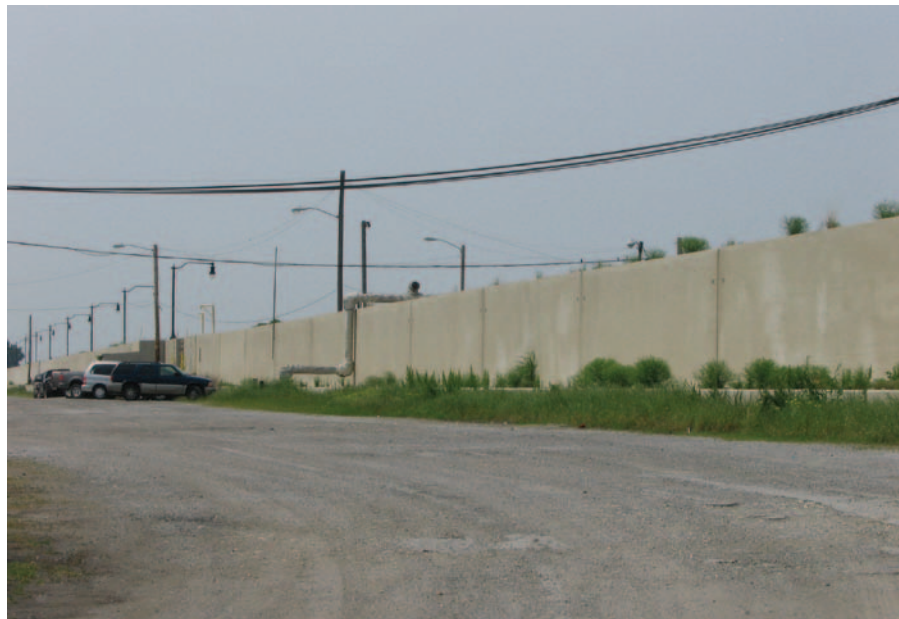
Figure 2

The Cairo seawall is on the Ohio River side at the bend where an earthen levee would be difficult to maintain. Factory worker vehicles are parked next to the seawall on May 20, 2011.

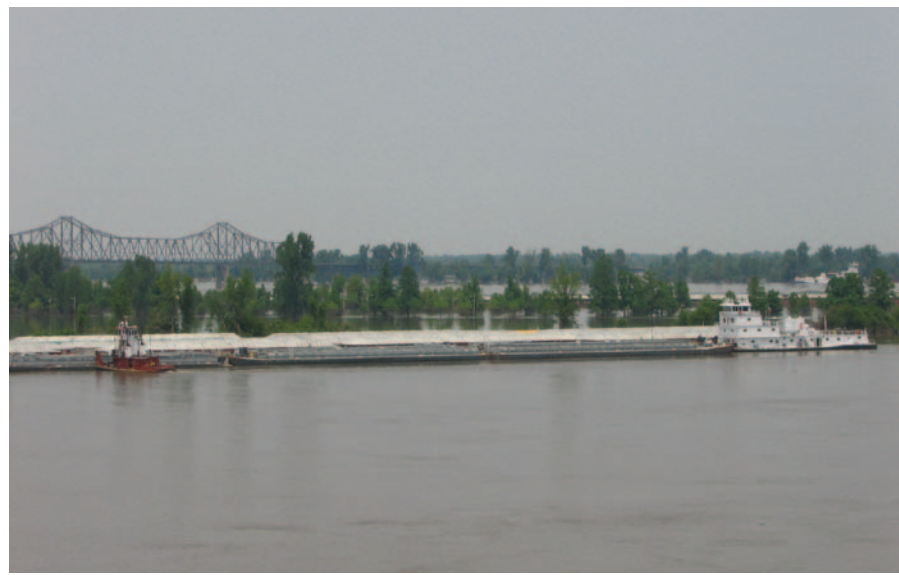
Figure 3

The Fort Defiance State Park trees are under water at the southernmost point of Illinois. The park is located south of Cairo levees and seawall and at the confluence of the Ohio (on the background) and Mississippi (on the foreground) rivers.

The Fort Defiance State Park (figure 3) is located just south of Cairo, Illinois, between the southernmost point of the Cairo levee and seawall system and the confluence of the Ohio and Mississippi rivers (figure 1). The park is the lowest point in the state of Illinois, with an elevation of 85

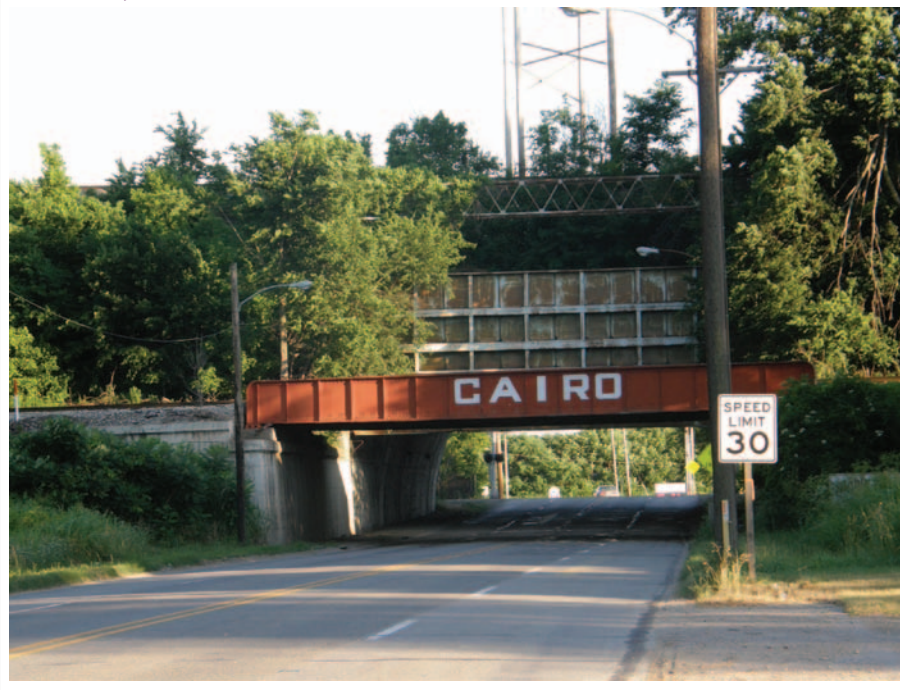
Figure 4

The raised railroad bed serves as the northern boundary of Cairo, Illinois, and provides an entry to the levee enclosed city for IL Route 3 traffic. Flood gates on this entry could seal the city behind embankments and seawall.

The city of Cairo is only 518 ha (1,280 ac) in size, and, if the levee system were to fail, it is estimated that more than 6.1 m (20 ft) depth of water would flow in rapidly and cover the city with 2,962 ha m (24,000 ac ft) of floodwater. The northern boundary of Cairo is two adjacent raised railroad beds (figure 4) that are 4.6 m (15 ft) and 12.2 m (40 ft) above Illinois Route 3 which passes underneath and through a tunnel. Between the raised railroad beds is a huge metal gate (figure 4), which can be lowered to block floodwaters from passing into Cairo from the north if the Cache River levee was to fail or be topped. During flood events, the entire city can be evacuated and sealed off from the floodwaters. If a levee or seawall system north of Cairo and on the Mississippi, Ohio, or Cache rivers failed, it would cause the flooding of Future City, Illinois, and the surrounding 809 ha (2,000 ac) of agricultural lands and cause the Cairo floodgate to be closed. The Future City area includes 1,214 ha (3,000 acres) of protected land (Tice silty clay loam, Riley silty clay loam, Darwin silty clay loam, and Cape and Karnak silty clay loam) (Parks and Fehrenbacher 1968) north of Cairo and south of Cache River levee. The Future City area has the capacity to provide an additional 1,214 ha (3,000 ac) of unintended floodwater storage if the Cache River levee break occurred and an additional 3,804 to 5,556 ha m (30,000 to 45,000 ac ft) of floodwater storage. This area, which is at a slightly higher elevation, could store water to a 3 to 4.6 m (10 to 15 ft) depth depending on location and also includes levee-protected Illinois farmland (Olson et al. 2011).

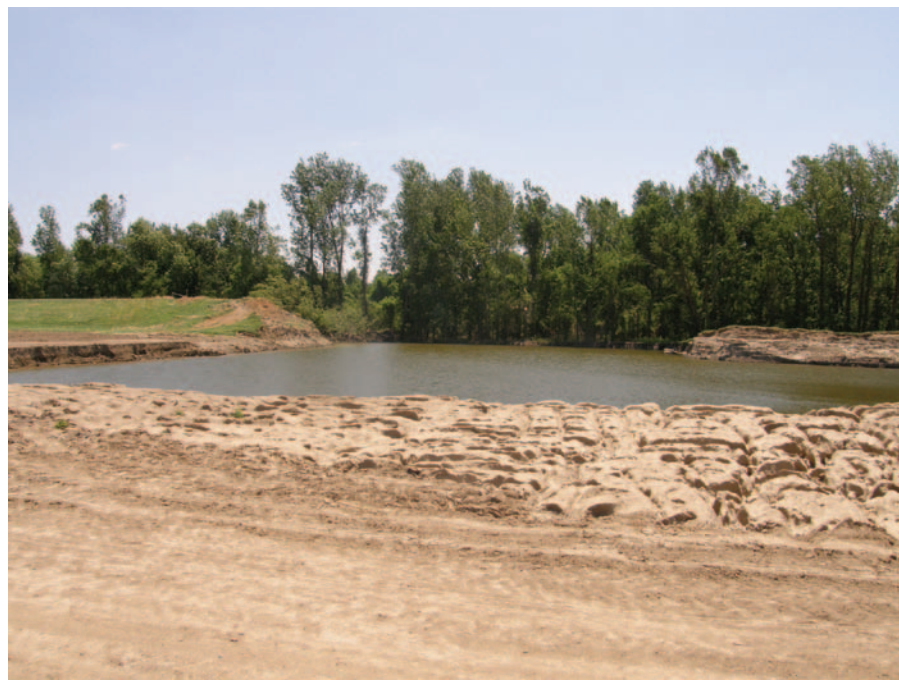
Figure 5

The Birds Point levee was the site of the first explosion and is visible with remnants of the fuse plug levee and the crater lake extending into the adjacent agricultural lands that are still under floodwaters.

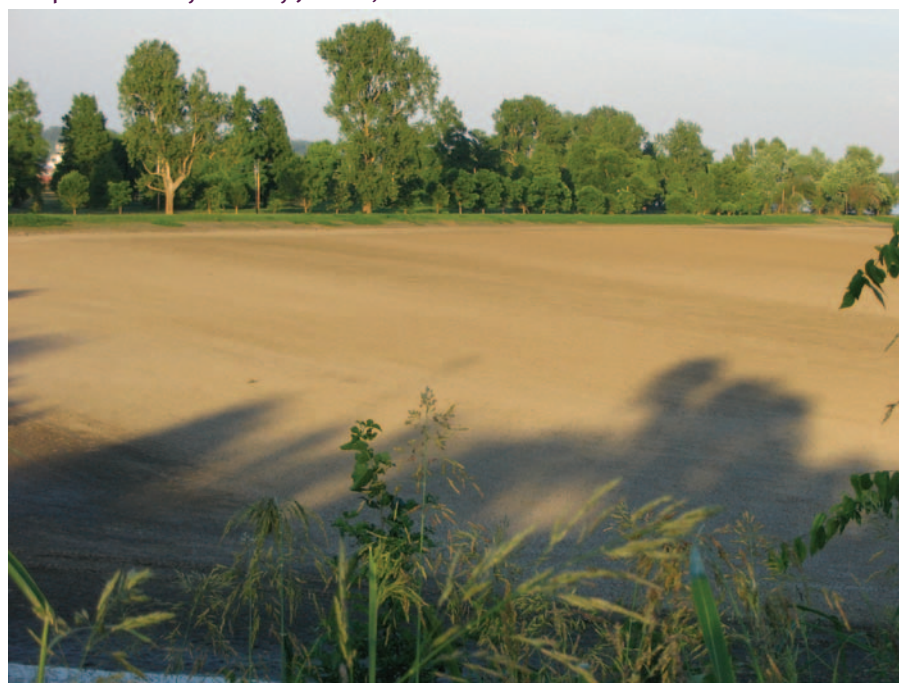
Figure 6

Fort Defiance State Park and adjacent Illinois agricultural land after Ohio River dropped and planted to soybeans by June 10, 2011.
